CARR - 684

1050 MEDFORD ROAD

FIELD SHEET--HISTORIC RESOURCES SURVEY

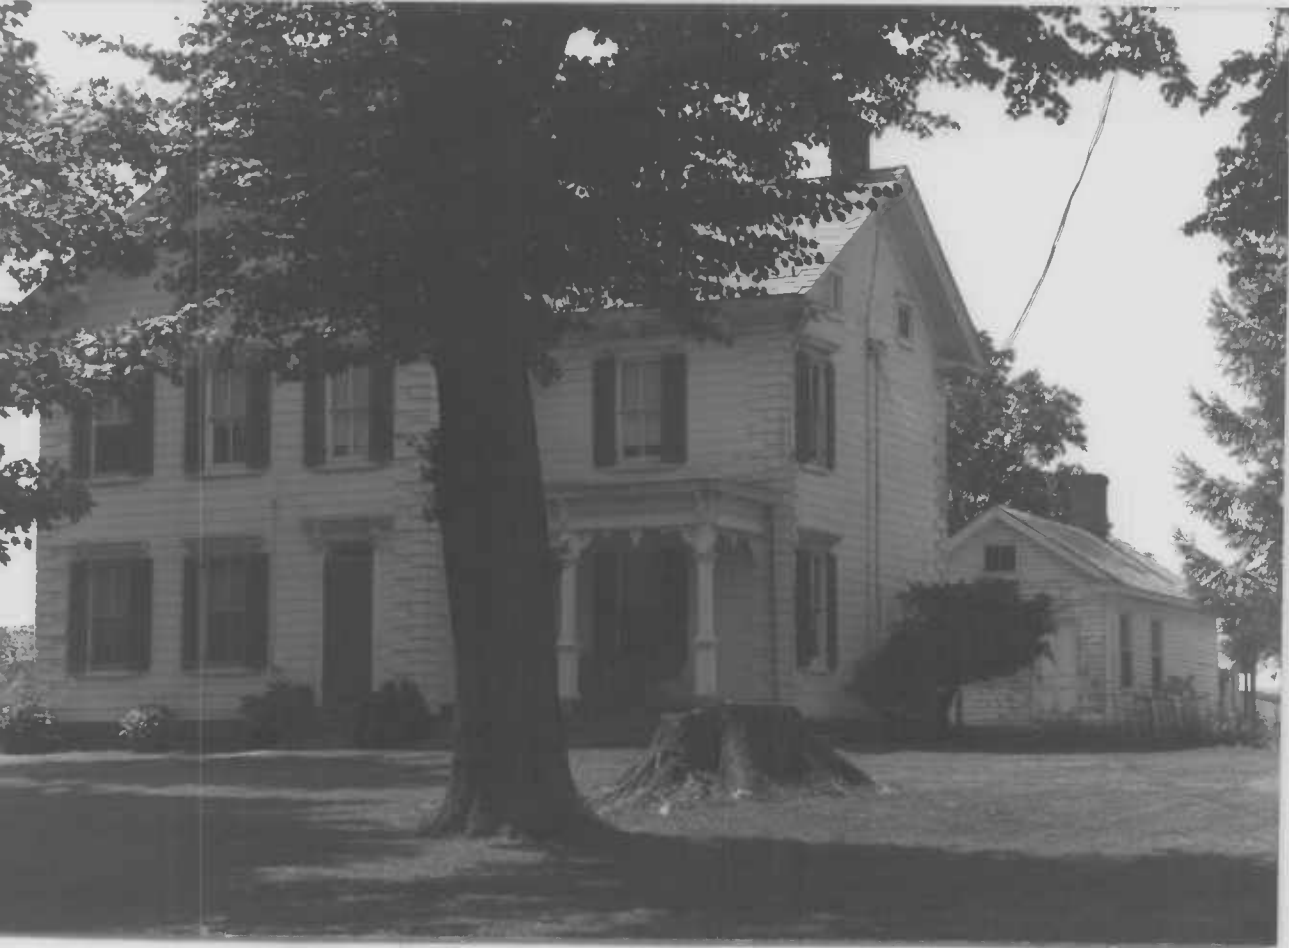
1. CARR-684 1060 MEDFORD ROAD
2. Carroll County, Maryland
3. Joe Getty
4. August 1983
5. Md. Historical Trust, Annapolis, Md.
6. East and north elevations (camera
facing southwest)
7. 1/1
